Manhole Inspection Summary

Manhole # S17GG_008MH

Location Address: **1534 MORELAND AVE**

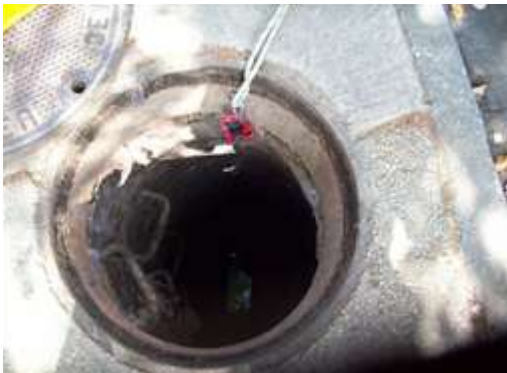
Top View

storm drain lid

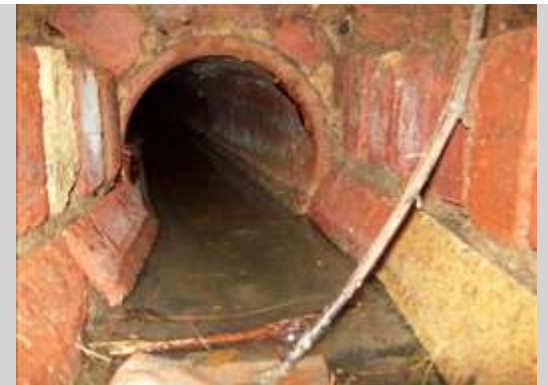
6 O'Clock Inflow

8 in. Circular Gravity Sewer
Pipe In @ 6 O'Clock

Pipe Height: (in.) Direct
Pipe Material: **Clay** ☐ Pipe Lined
Invert Depth: **9.96** (ft.) Flow Characteristics: **None**
Deposits: ☒ None ☐ Mud ☐ Sludge ☐ Debris ☐ Grease
Silt Depth: (in.) Deposits Extent:
Infiltration: **None** Pipe Seal Cond: **Sound**
